Field Visit Notes: Davidson Canyon

April 20, 2016

Brian Powell and Julia Fonseca

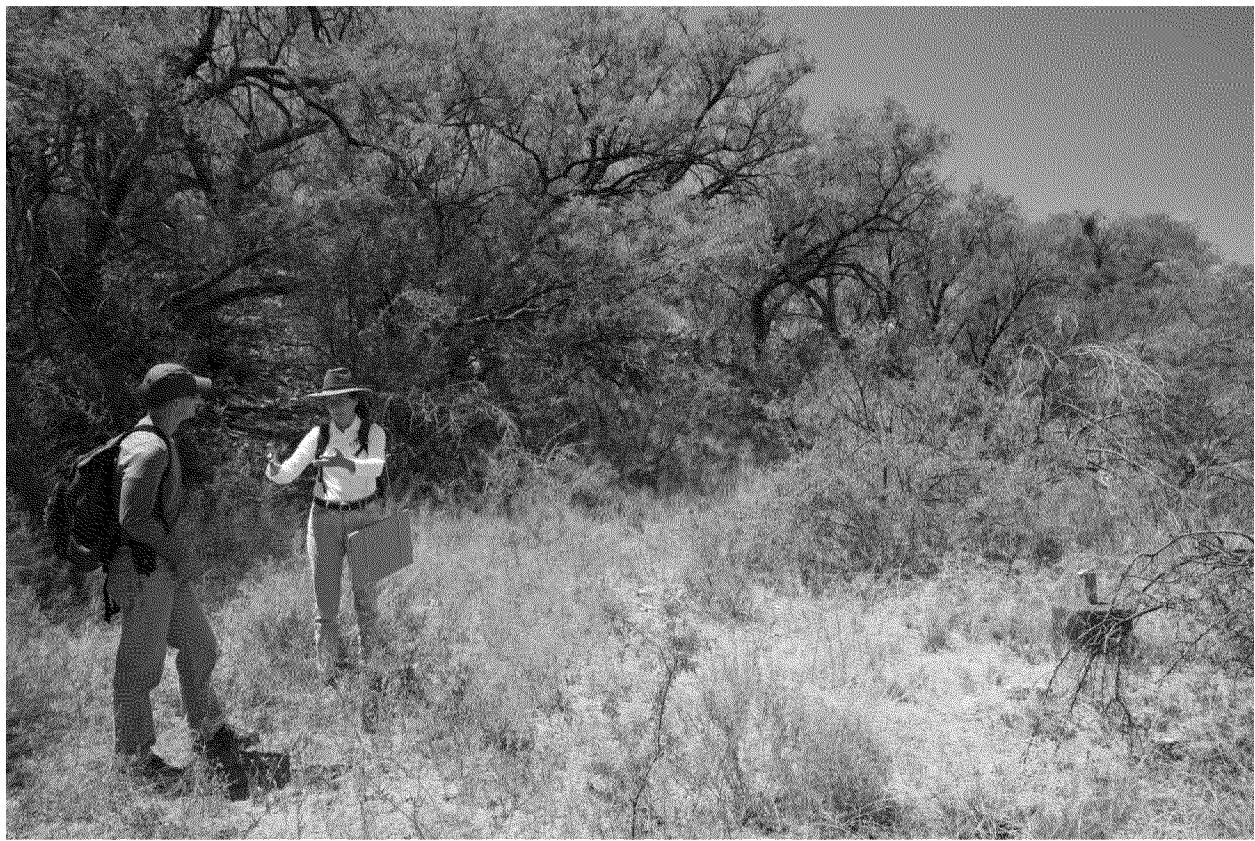
We parked on a terrace in Davidson Canyon and hiked upstream to the end of the County boundary, observing a number of important features along the way including the ALERT station, nearby Davidson2 well, a wetted reach, wetland plants, and riparian vegetation.

Figure 2. Davidson 2 well (right side of image).

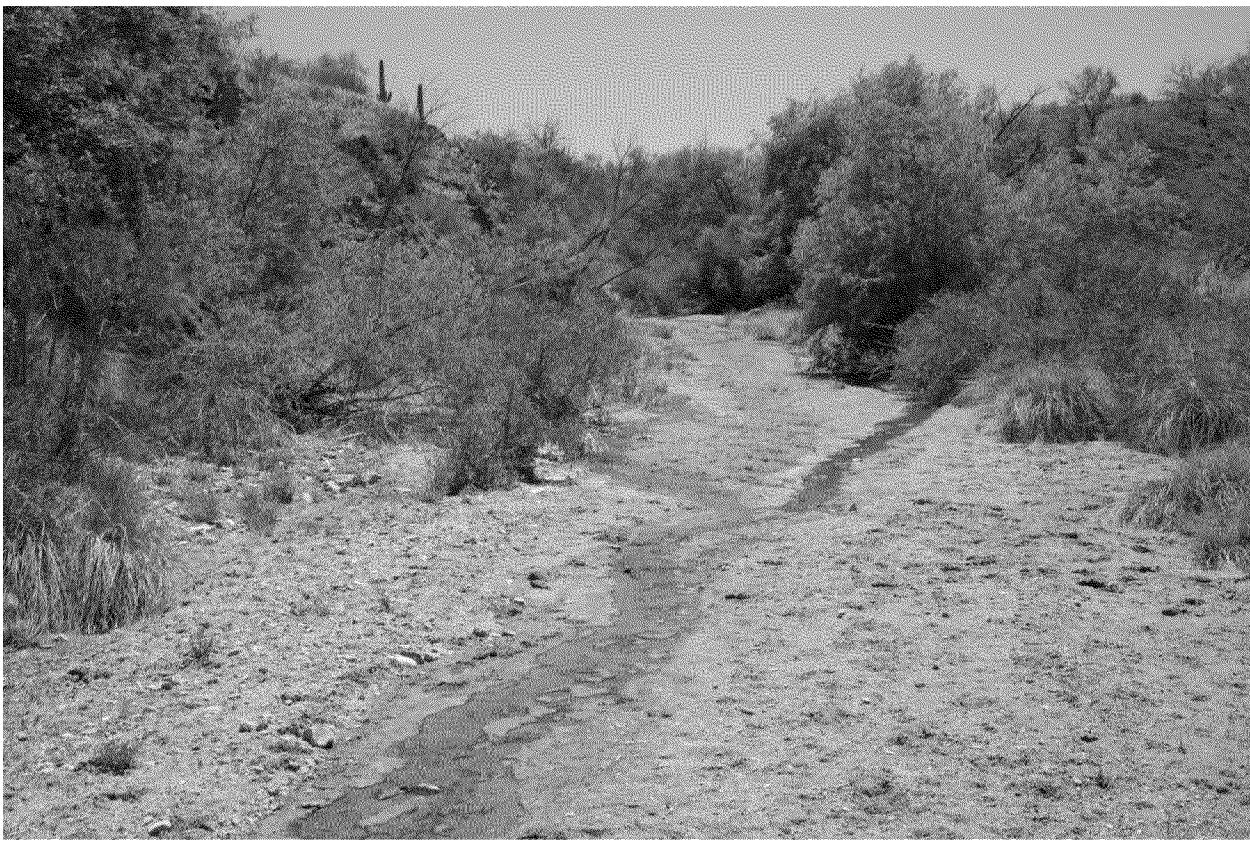
We encountered a 111m section of the canyon that was flowing. The start and stop points of the flow were (UTM, NAD 83):

Start: 3539274/533267

End: 3539374/ 533261

Figure 3. Wetted stretch of Davidson Canyon. Active flow was observed.

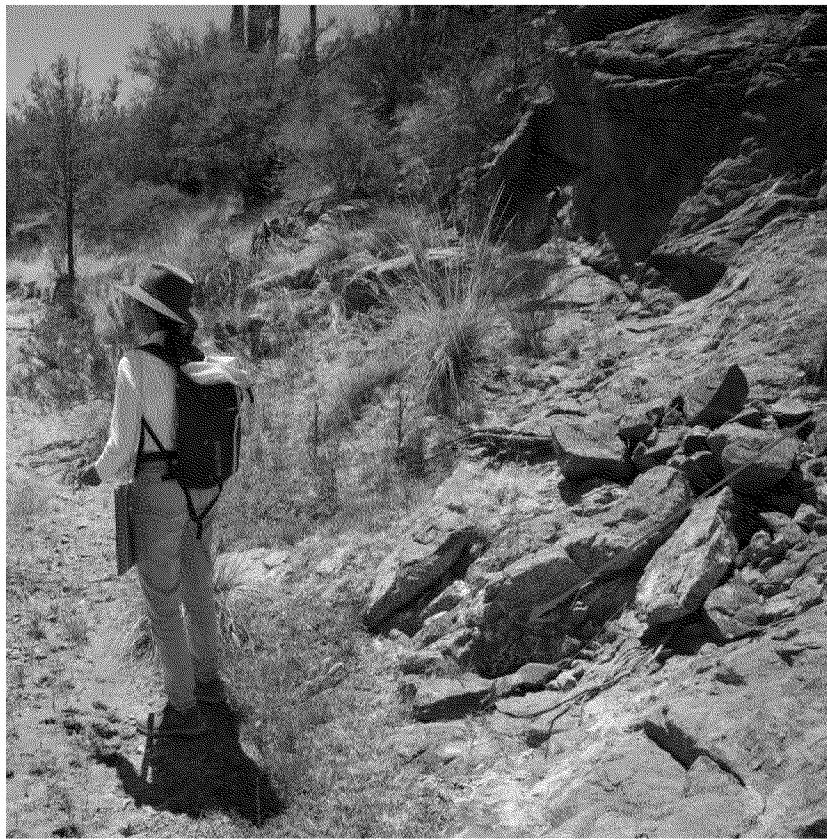
Moist soil and salt buildup

Figure 4. Moist soil above the wash bottom, salt buildup and wetland plants along Davidson Canyon.

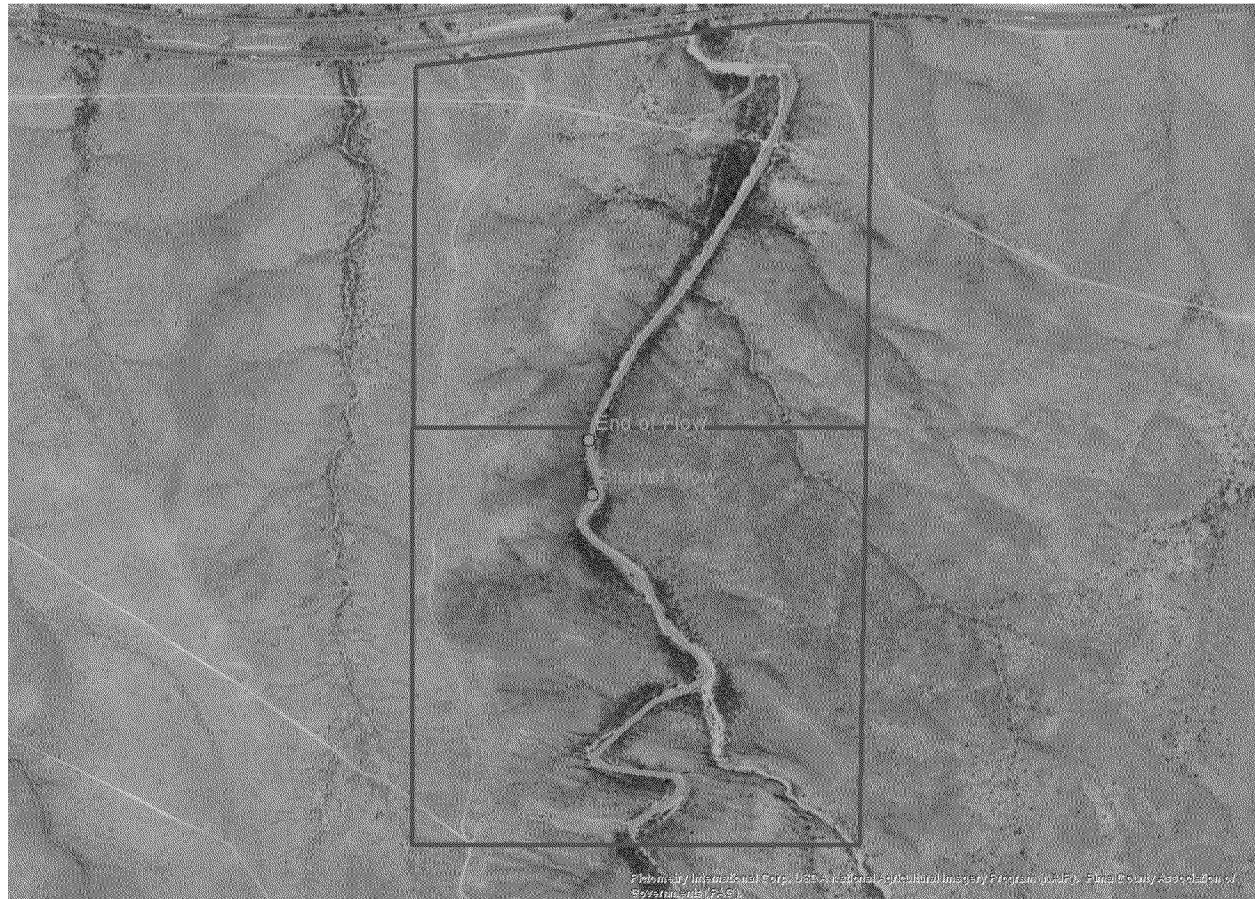
Figure 5. The orange line shows the route taken during the hike. County land is noted in red. Start and end of active streamflow are also noted. The southern terminus of the hike was at the fence separating the county land and State land.

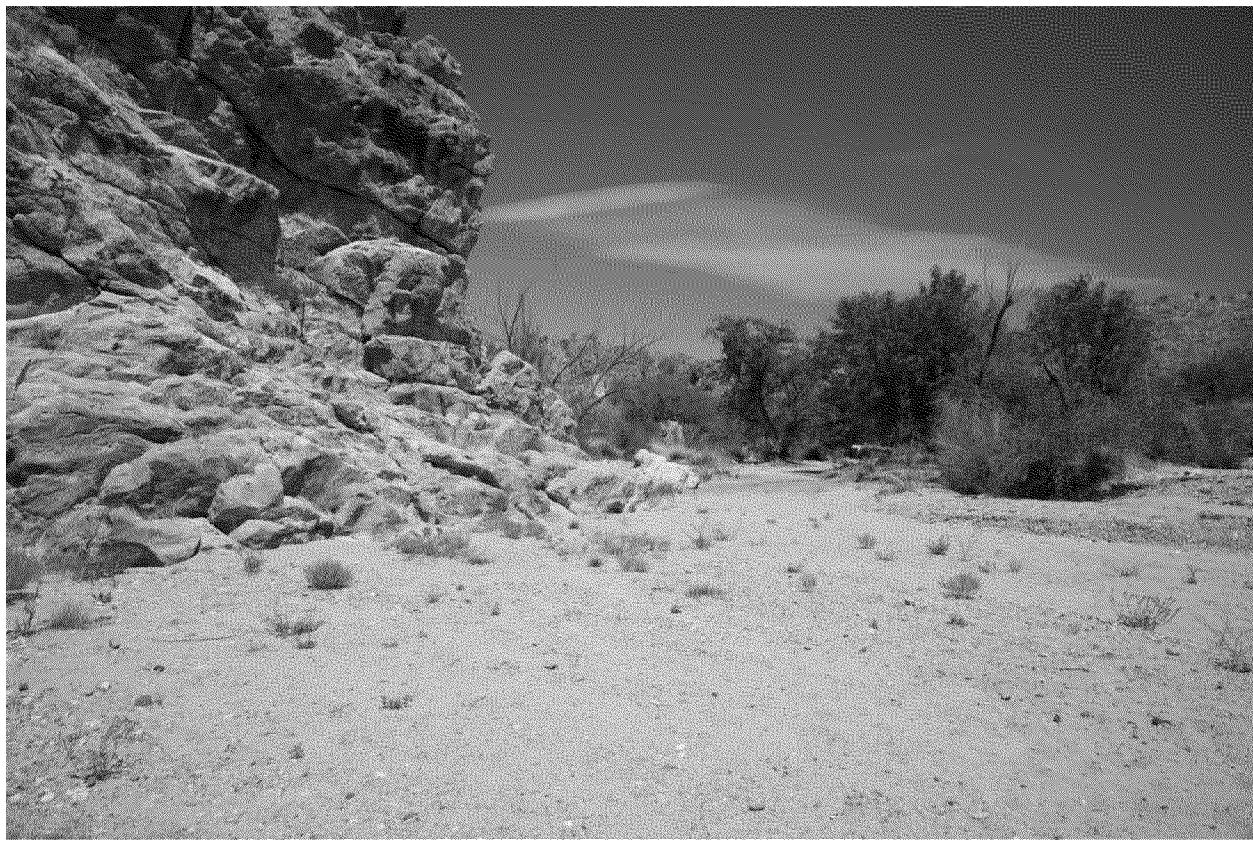
Figure 6. Bedrock outcrop near the southern end of the County property. Permanent surface water has been noted here in the past and it is believed to be the site where the Arizona Game and Fish Department found longfin dace in 2005.

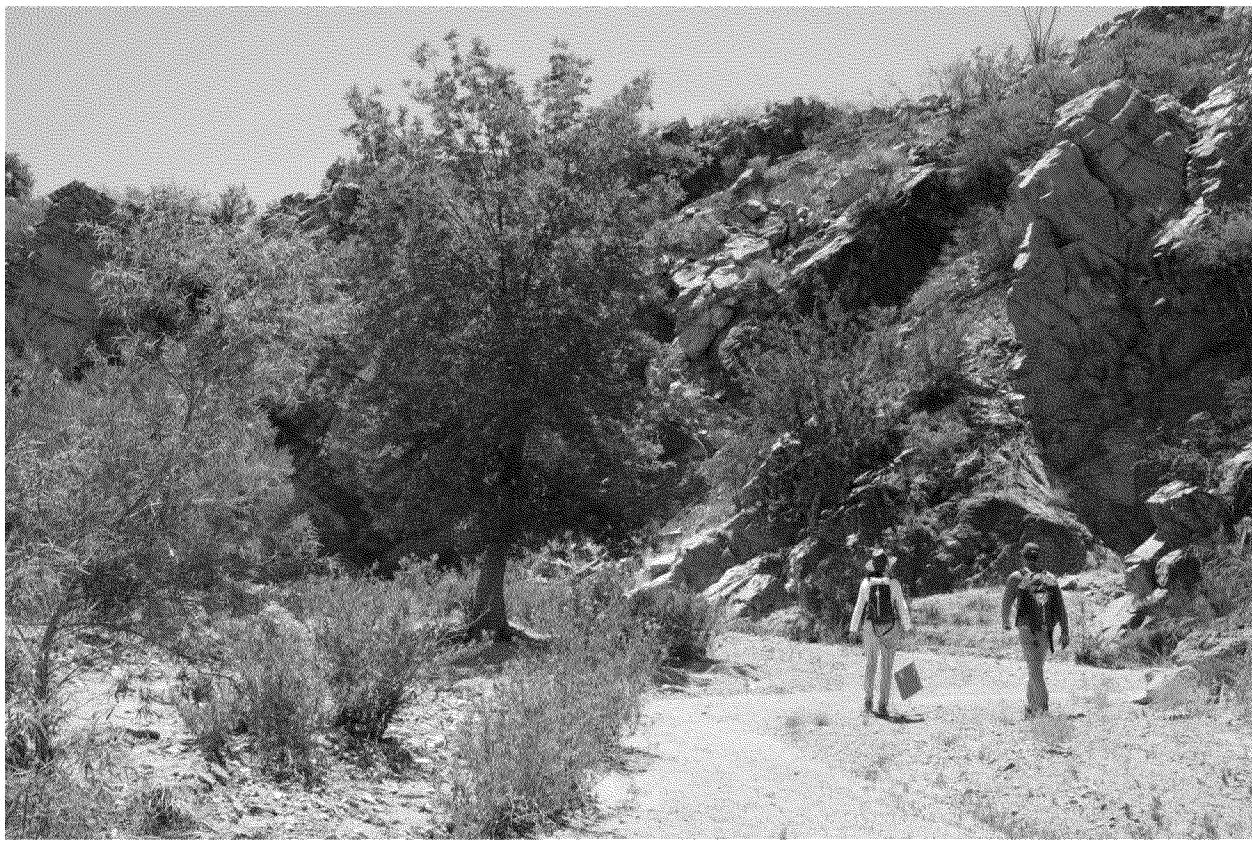
Figure 6. Gooding's willow (left side of picture), Arizona ash (tall tree in picture) and netleaf hackberry (not pictured), all riparian trees, are common throughout the area we visited.
